FINAL REPORT
INVESTIGATION OF SMOOTH-BONDED METAL LINERS
FOR GLASS FIBER FILAMENT-WOUND PRESSURE VESSELS

by
J.M. Toth, Jr. and D.J. Soltysiak

Prepared for
NATIONAL AERONAUTICS AND SPACE ADMINISTRATION
May 1967
CONTRACT NAS 3-6293

Douglas Aircraft Company, Inc.
Missile and Space Systems Division
Santa Monica, California

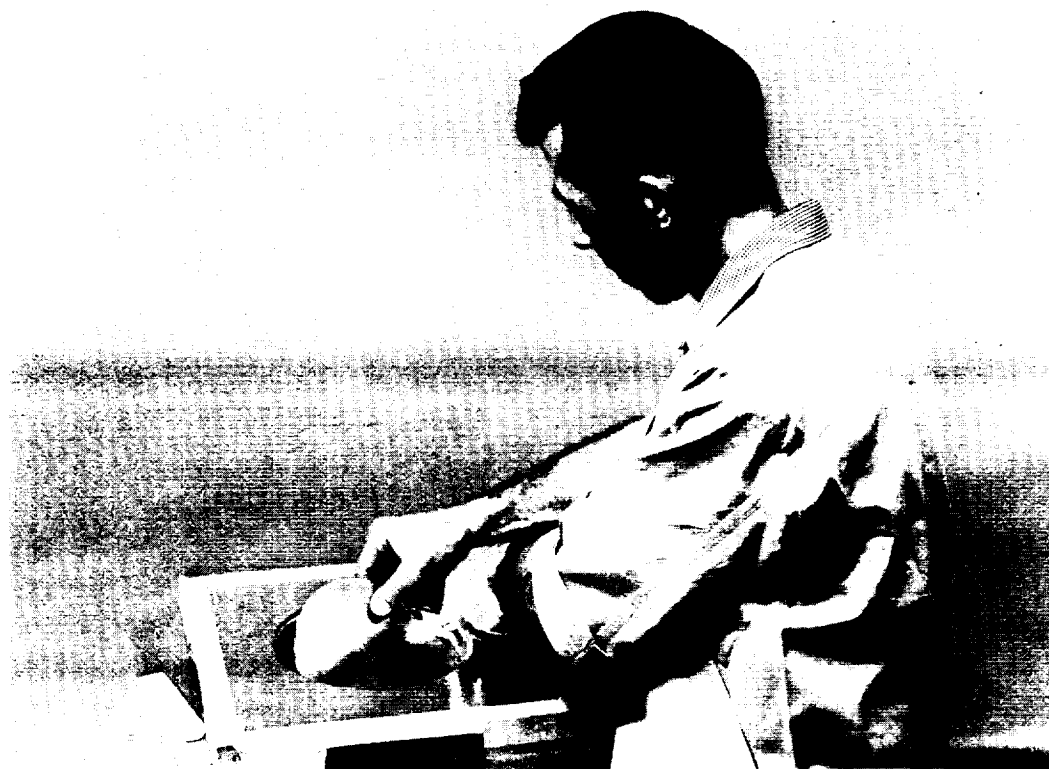
Figure 21. End-Flange Liner Fabrication

a. Forming with Teflon Tool

b. Removal of Center Blank

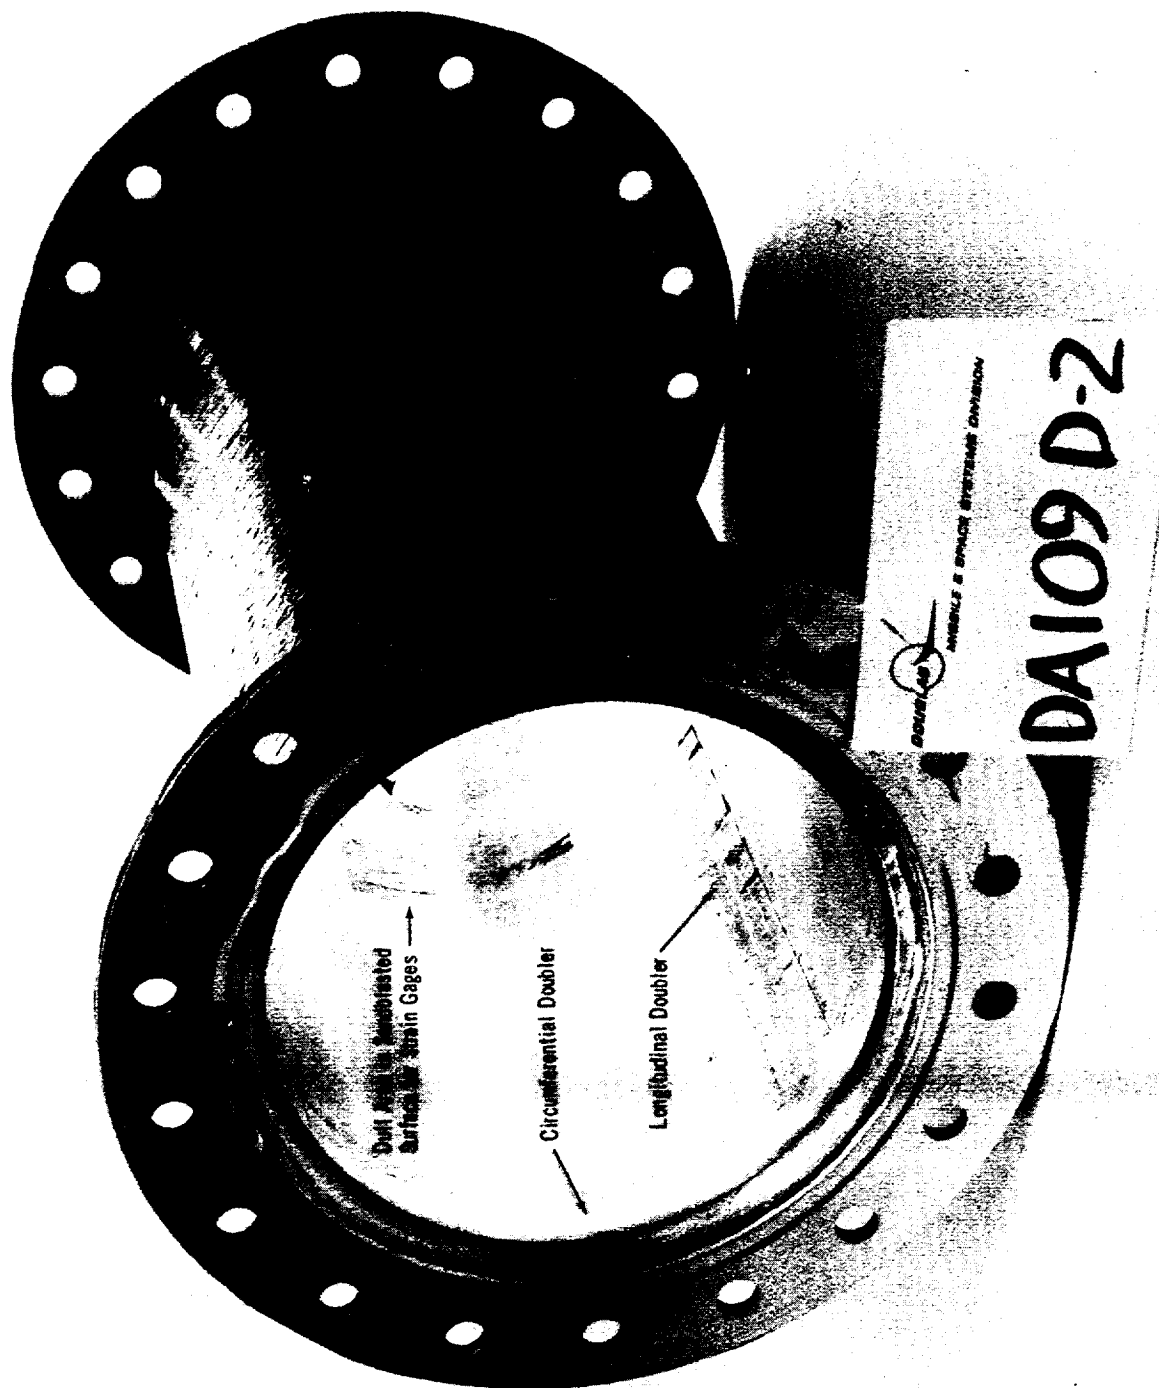
Figure 25. Vessel D2. Post-Test, General View

Post-test inspection revealed that the liner in all but the longitudinal doubler area looked excellent. There were no cracks, wrinkles, or buckles. The circumferential doublers appeared satisfactory. There were some voids that appeared as indentations but no cracks, bubbles or debonding.

In the seal area at the inner edge of the backup ring, cracking of the foil occurred. At one end there were two cracks, one was 3/4-in. long and the other was 1/4-in. long. At the other end there was one crack 3/4-in. long. The longitudinal doubler contained voids that appeared as delaminations and bubbles in the test section, particularly along the edges (fig. 25). Cracking of the doubler occurred in some of the delaminated buckled areas.

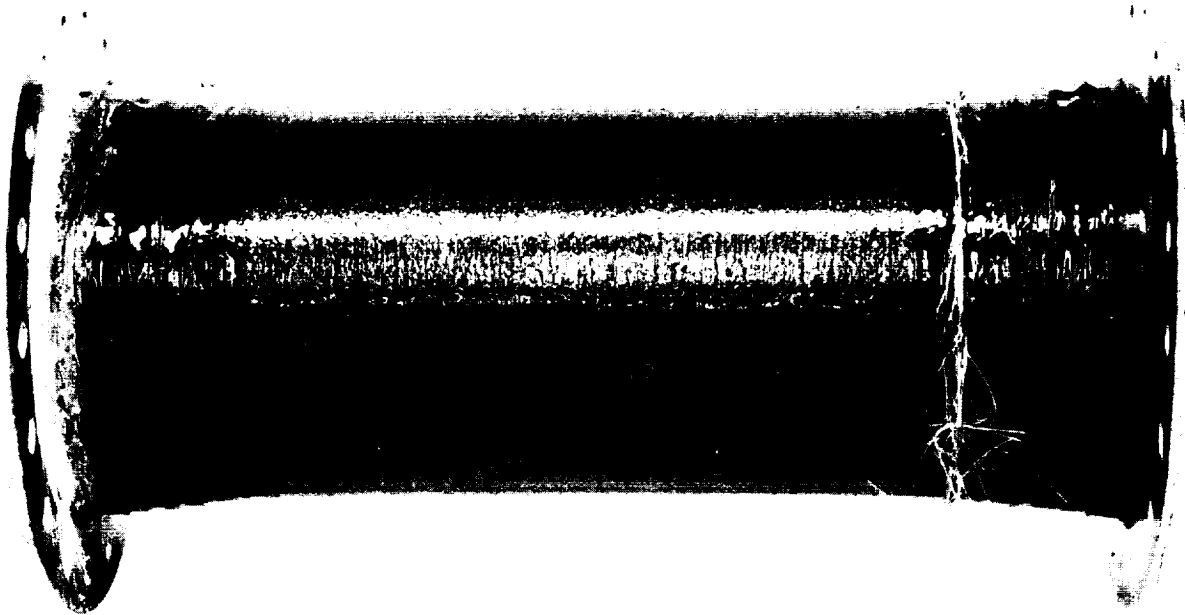
Figure 35. Vessel TA-2—Post-Test Overall View

The exterior of the vessel appeared satisfactory, with only a minimum of resin crazing. The primary aluminum liner remained in excellent condition except for the longitudinal seam. There were no voids, bubbles, delaminations, wrinkles, or buckles in the primary liner test section.

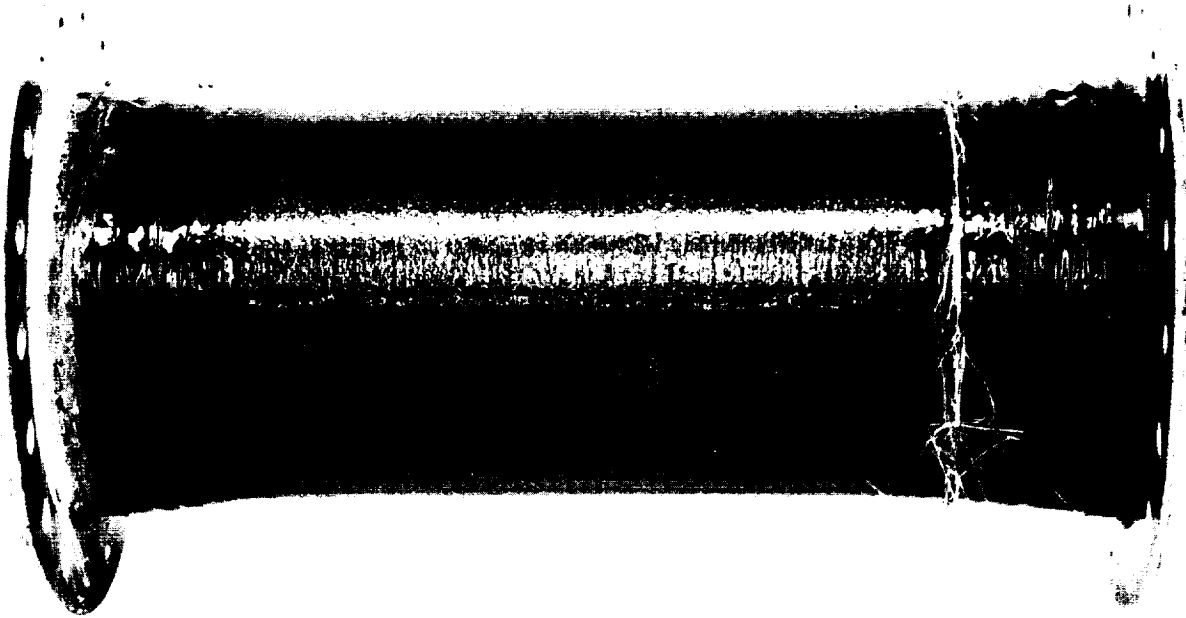
Figure 35. Vessel TA-2—Post-Test Overall View

Post-test inspection of the vessel revealed that failure occurred in the longitudinal glass because of a displacement, caused by the hoop overwinding in the build-up area. The displacement was much more severe than noted during the fabrication. The vessel is shown post-test in figures 35 and 36. During the fabrication of the vessels from TA-3 onward special attention was paid to eliminating the displacement problem.

Post-test inspection of the vessel revealed that failure occurred in the longitudinal glass because of a displacement, caused by the hoop overwinding in the build-up area. The displacement was much more severe than noted during the fabrication. The vessel is shown post-test in figures 35 and 36. During the fabrication of the vessels from TA-3 onward special attention was paid to eliminating the displacement problem.
